**US Army Corps
of Engineers**

USACERL Technical Report M-91/02

October 1990

Exterior Insulation and Finish Systems (EIFS) on U.S. Army Facilities: Lessons Learned

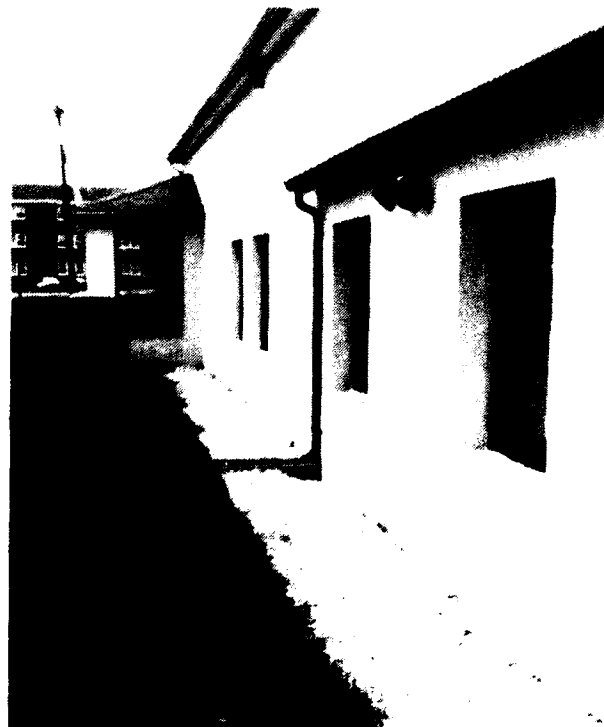
Figure 17. Gravel border around building to keep lawn care equipment away from EIFS.

Damage caused by lawnmowers or other yard maintenance equipment can be lessened by providing a gravel rock border around the buildings as shown in Figure 17. Shrubbery can also be used as long as it is not of the climbing variety, which can actually penetrate into some systems.

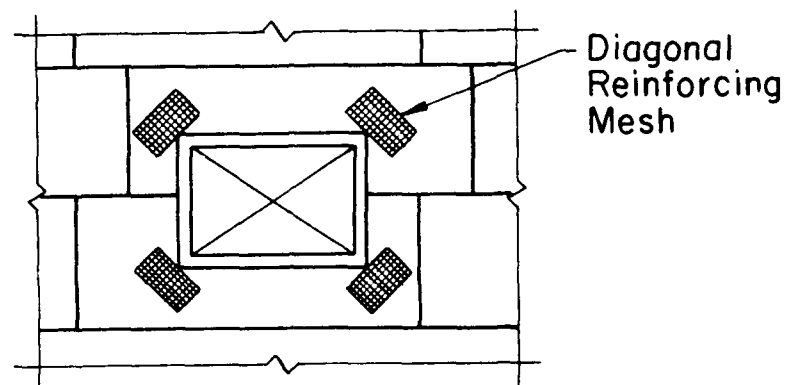
Figure 22. Schematic showing manufacturers' recommended use of diagonal reinforcing fabric at window and door corners. (This information was printed with the permission of Dryvit Systems, Inc., One Energy Way, P.O. Box 1014, West Warwick, RI 02893.)

Most of the cracking in EIFS due to these common causes could be prevented. To lessen the occurrence of corner-initiated cracking, most manufacturers now require that diagonal pieces of reinforcing fabric be placed at the corners of windows and doors (Figure 22). Also, the insulation boards should be placed so that the vertical edges of the board do not line up with the vertical edges of the window, door, or other such wall penetrations (Figure 23).

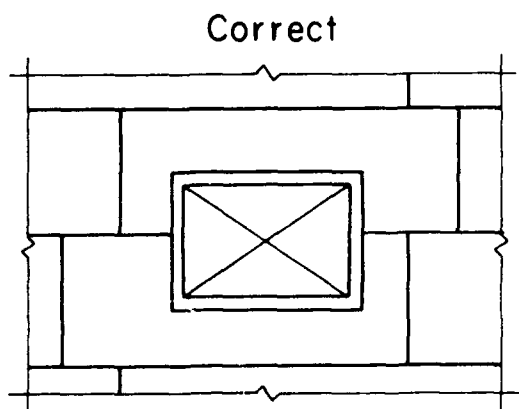
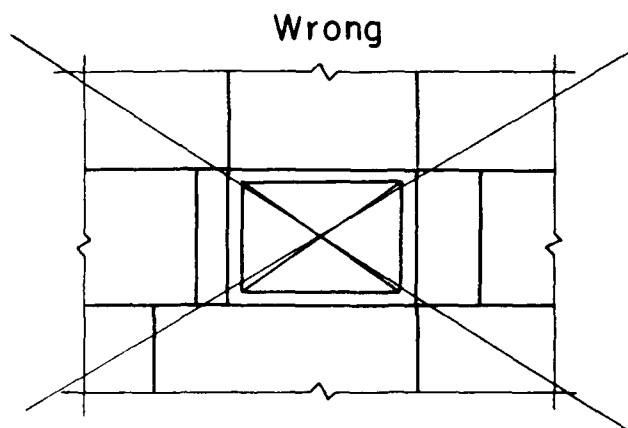
Figure 23. Insulation boards at window penetrations, placed (a) properly, (b) improperly. (This information was printed with the permission of Dryvit Systems, Inc., One Energy Way, P.O. Box 1014, West Warwick, RI 02893.)

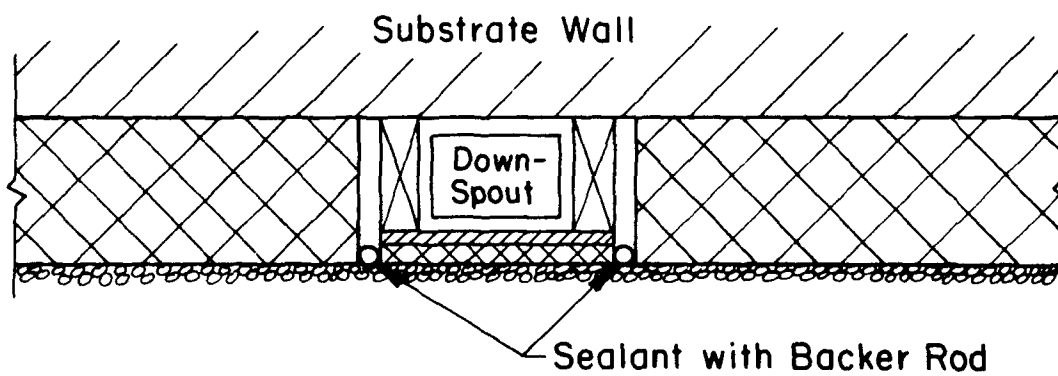
Figure 27. System detailing needed to bridge underlying downspout.

Careful attention should be paid to the treatment of gutters and downspouts in the building design. Downspouts should not be concealed. If this is not possible, the bridge section must be isolated from the adjacent wall (Figure 27) and the downspout itself. The bridge section must not be adhesively attached to the downspout. The system and the downspout must be free to move independently of each other. Any existing installations with these conditions present will need to alter the system to conform to the above recommendations. Leaking, damaged, or missing gutters and downspouts must be repaired or replaced to reduce the possibility of water infiltration into the EIFS.
